BEAVERDAM RUN DAM

FD-NO. PA. 805

PHASE I INSPECTION REPORT

Beaverdam Run Dam (PA 805), Ohio River
Basin, Beaverdam Run, Cambria County,
Pennsylvania. Phase I Inspection Report.

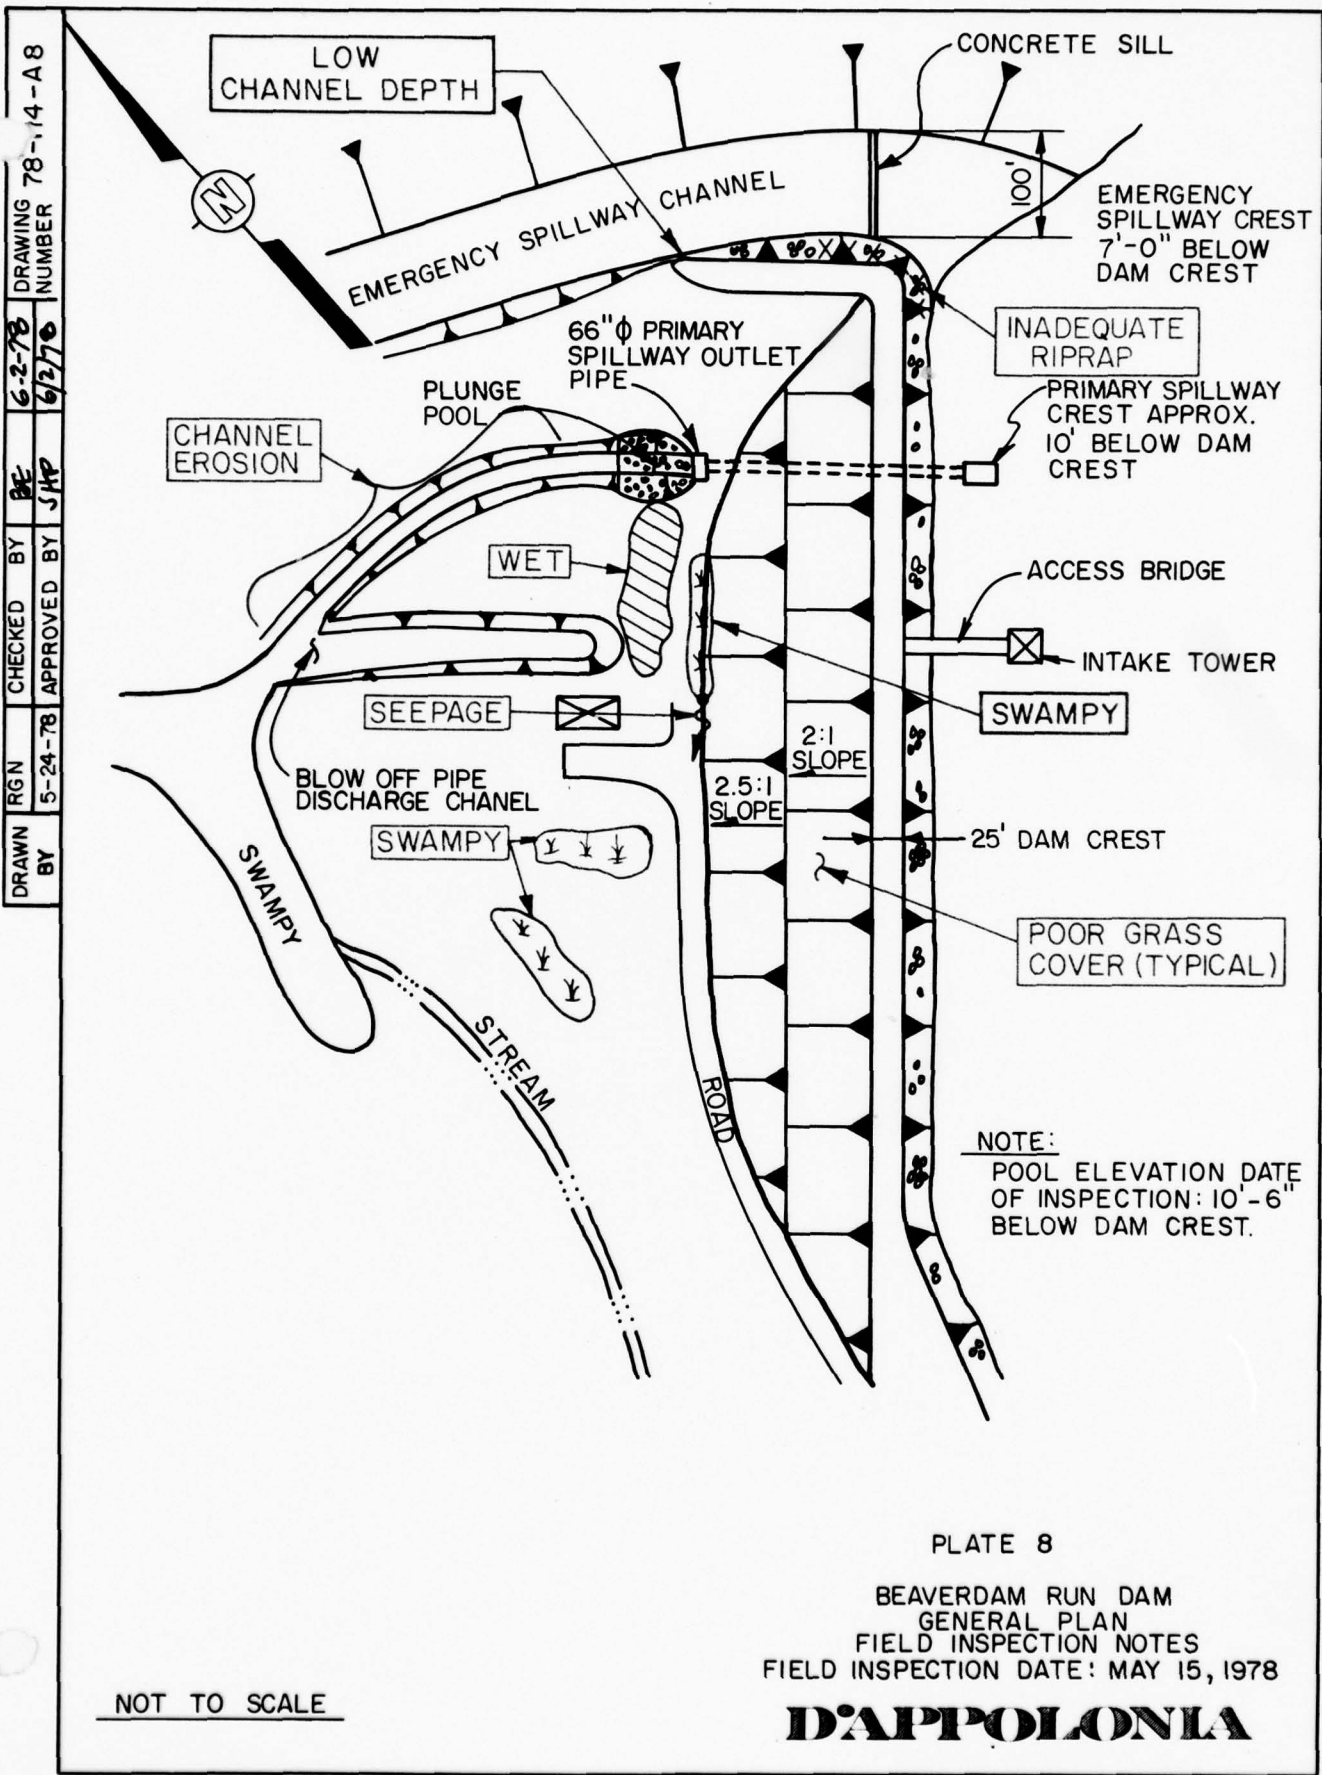
PLATE 8

The specific observations are illustrated in Plate 8 and in the photographs in Appendix C.

1. Only one seepage area was observed. This was located to the left of the primary spillway along the toe. The total flow was estimated to be approximately 2 to 3 gallons per minute (gpm). The effect of this seepage on the overall performance of the dam is considered to be inconsequential at the present time, but it should continue to be monitored to assure that it is not increasing. The reservoir has probably not been filled long enough for steady-state seepage through the dam to have developed.
2. Approximately four isolated wet and swampy areas were found below the toe on the valley floor (Plate 8). No significant flow appeared to be discharging from these areas.
3. The grass cover on the downstream face of the dam was considered to be poor, requiring reseeding.

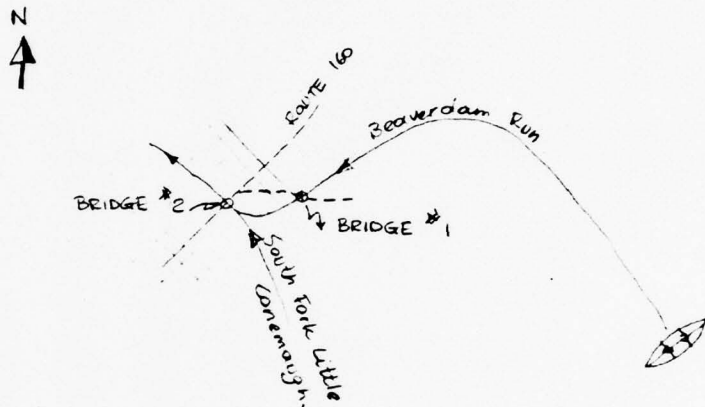
BRIDGE #1

BRIDGE ON TOWN STREET
